Surface deformation produced by the 1999 Chi-Chi (Taiwan) earthquake and interactions with built structures

U. S. Geological Survey
National Earthquake Hazards
Reduction Program
Award Number 01-HQ-GR-0122

William Lettis & Associates, Inc.
1777 Botelho Dr., Suite 262,
Walnut Creek, CA 94596

December 2003

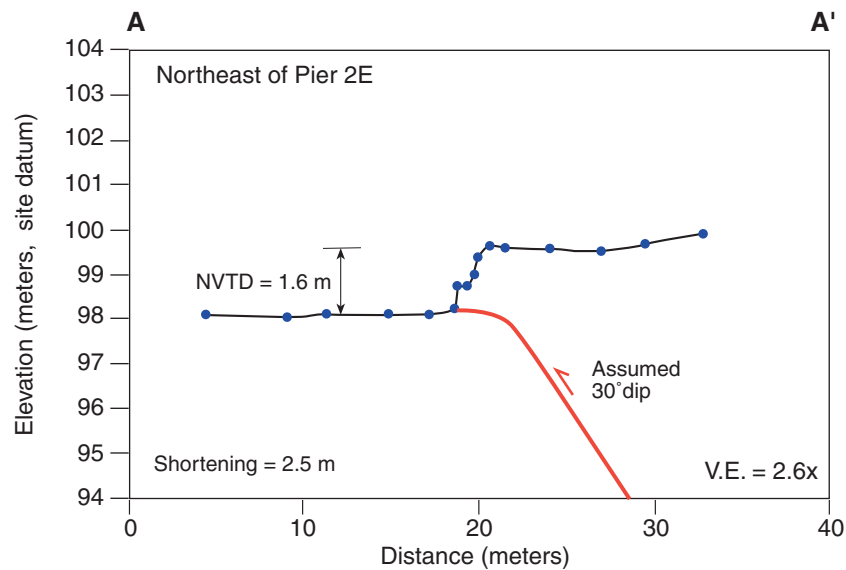
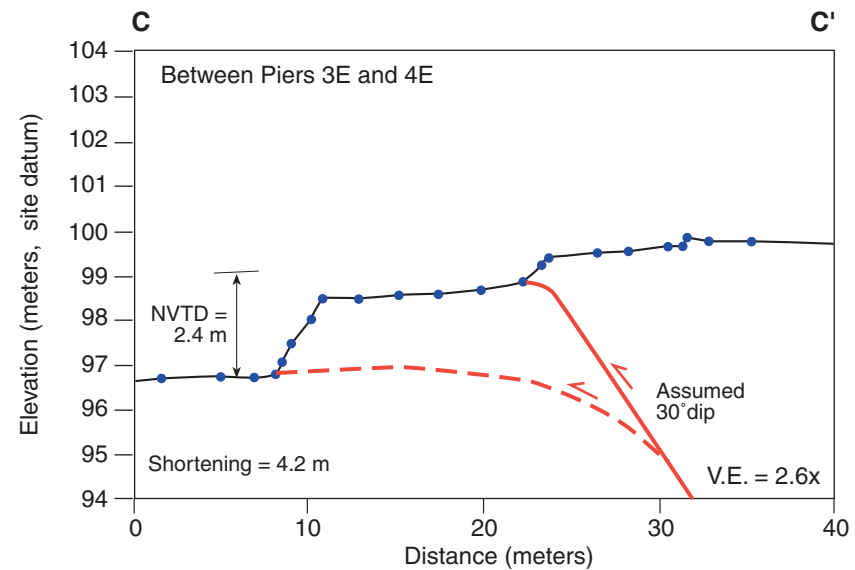
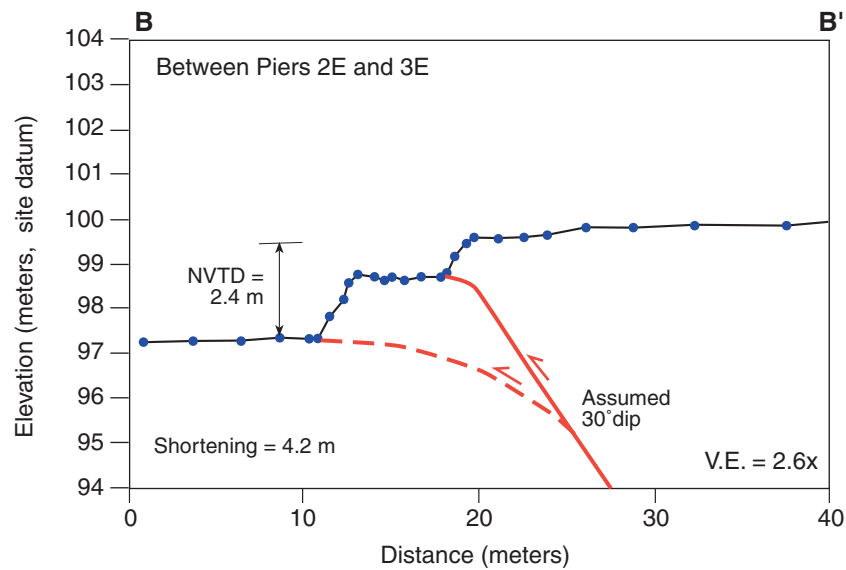
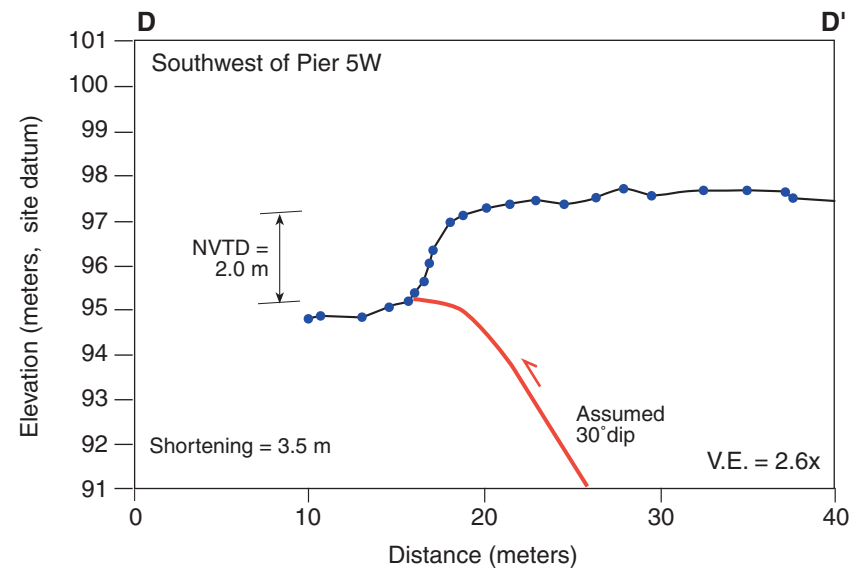
Figure 24. Topographic profiles across the Chelungpu fault at Wu Hsi Bridge. See Figure 23 for locations of profiles.
